Howard, A.J. and Coulthard, T.J. and Knight, D. (2017) 'The potential impact of green agendas on historic river landscapes : numerical modelling of multiple weir removal in the Derwent Valley Mills world heritage site, UK.', *Geomorphology*, 293 (A). pp. 37-52.

The potential impact of green agendas on historic river landscapes: Numerical modelling of multiple weir removal in the Derwent Valley Mills World Heritage Site, UK

A.J. Howard^{a,b,*}, T.J. Coulthard^c and D. Knight^d

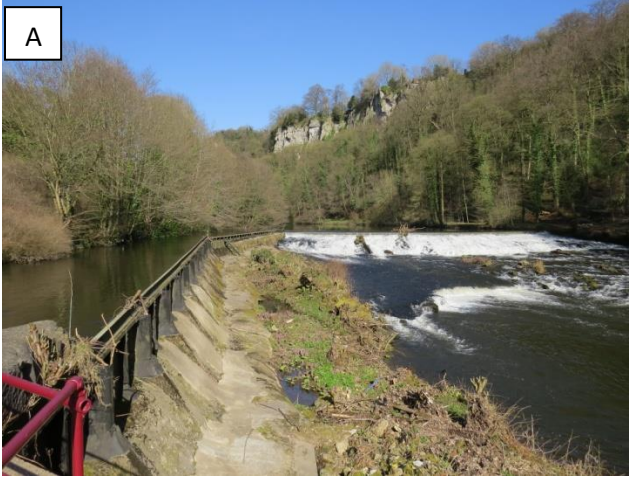
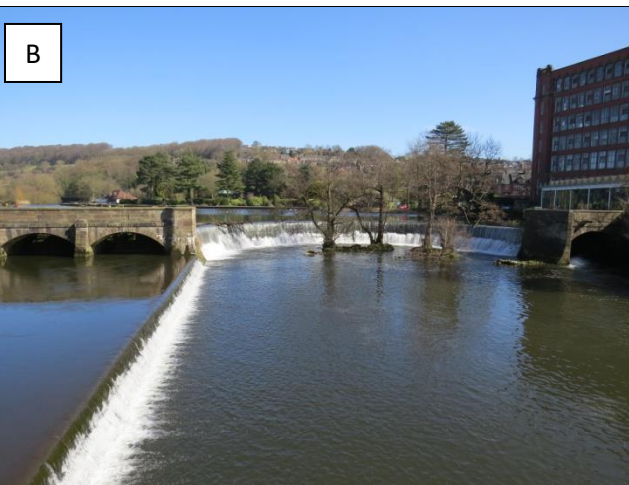
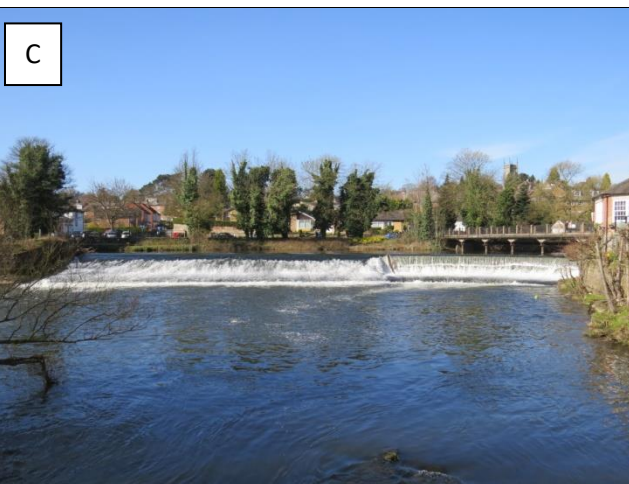
Fig. 2. Examples of listed weir structures along the Derwent listed in Table 1: (A) is Masson Mill weir; (B) is Belper West Mill Horse Shoe weir; (C) is Boar's Head Mill weir.

Location	Description
Masson Mill Weir, No 1, Fig. 1	LISTED GRADE II*. Weir has convex shape. It is suggested to have been built in this form because of the underlying rock structure at this point in the river. Whilst undated, it was probably an early addition to the Masson site, if not contemporary with the textile mill itself.
Cromford Mill Basin Weir and Culverts, No 2	LISTED GRADE I. The basin weir was constructed around 1777, in the middle of the mill yard at Cromford. Note that this weir, although part of the site designation, is away from the River Derwent on a tributary stream.
Belper West Mill Horseshoe Weir, No 3	LISTED GRADE II*. Convex shape as name suggests. Built 1797 by Jedediah Strutt but modified and increased in height in 1819 and 1843. This structure replaced Jedediah Strutt's first weir further north that powered the South and North Mills.
Hopping Mill Weir, Milford, No 4	LISTED GRADE II. The current weir dates from 1799-1801, but occupies the site of an earlier structure. Substantially altered by the Strutt family when they built their first cotton mill in Milford, it has a stone paved sloping surface and a concave curve upstream. The weir served three sites: on its north side, a corn mill and a fulling mill; on its south side, via a goyt, Strutt's printing mill and bleach works; farther downstream, south of the bridge across the Derwent, the main cotton mill site.
